Long Term Plan for the Rehabilitation of  
the Belrockton Museum and Community Center

**Long-Term Plan for Rehabilitation of the  
Belrockton Museum and Community Center**

Re: Belrockton Existing Conditions and  
Recommendations for Repair

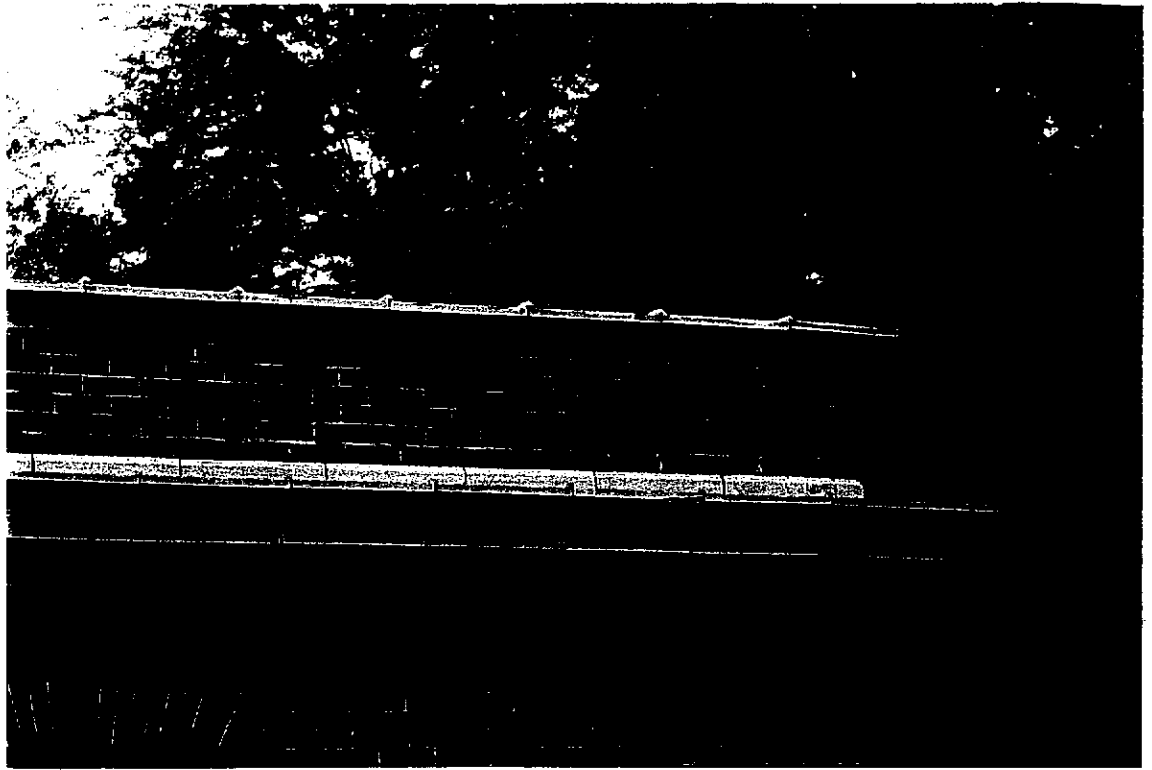
(Above) The joints in the terra-cotta cornice are open and allow water to enter. This will eventually crack the terra-cotta and cause it to become loose, sag, or fall off. The mortar joints in the parapet section above the cornice are especially deteriorated because the roof flashing lets water into the mortar joints.

- Remove paint from terra-cotta.
- Repoint all joints, and inspect for loose terra-cotta pieces.

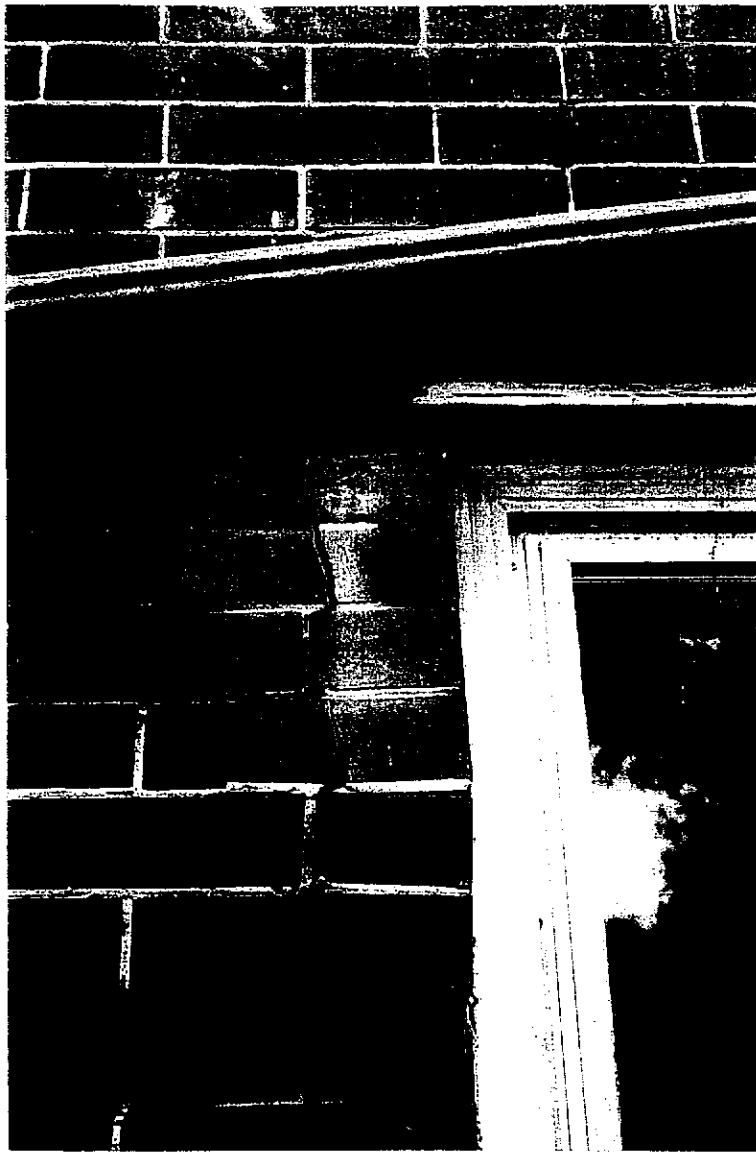
(Left) The steel lintel over this window on the West elevation is rusted because water has entered into deteriorated mortar joints. Freeze thaw action in and between the joints has forced the bricks to crack and shift. The down spout also traps water against the wall which increases the problem. This is an extreme case which exists in four locations on the West elevation.

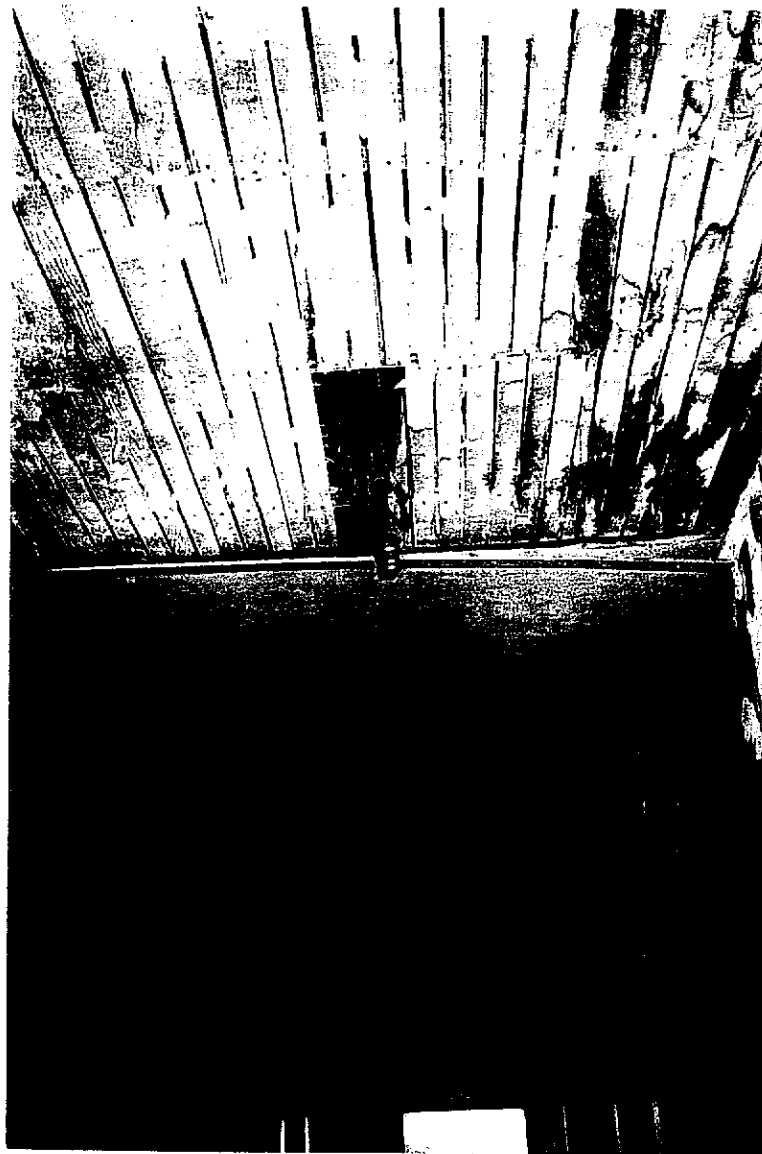
(Left) The third floor ceiling and walls are severely water damaged, and the plaster has delaminated. In this case, some of the plaster was replaced with homosote boards which have also become water saturated and are bulging and sagging.

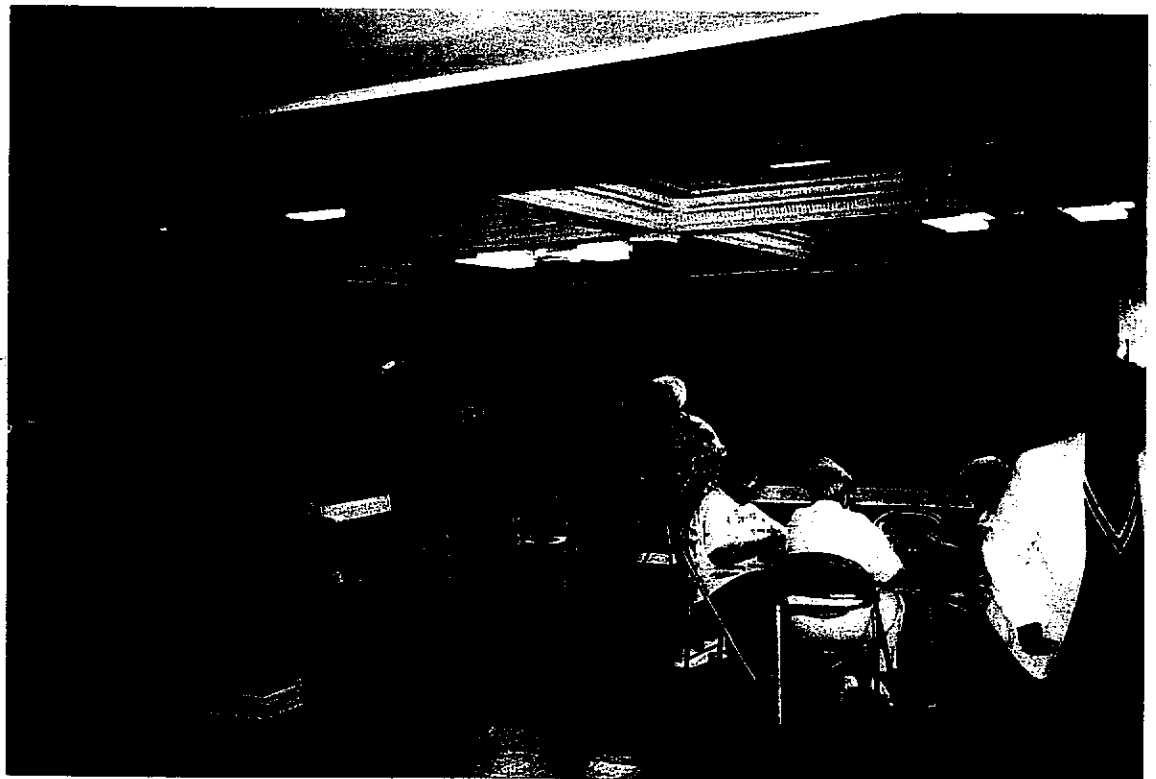
(Below) The meeting room is made up of the original dining room (with a tin ceiling) and a portion of the original kitchen. Renovation plans include removal of the wood paneling, installing new lighting, finishing the original wood floor, and replacing the partial vinyl floor with a wood floor.

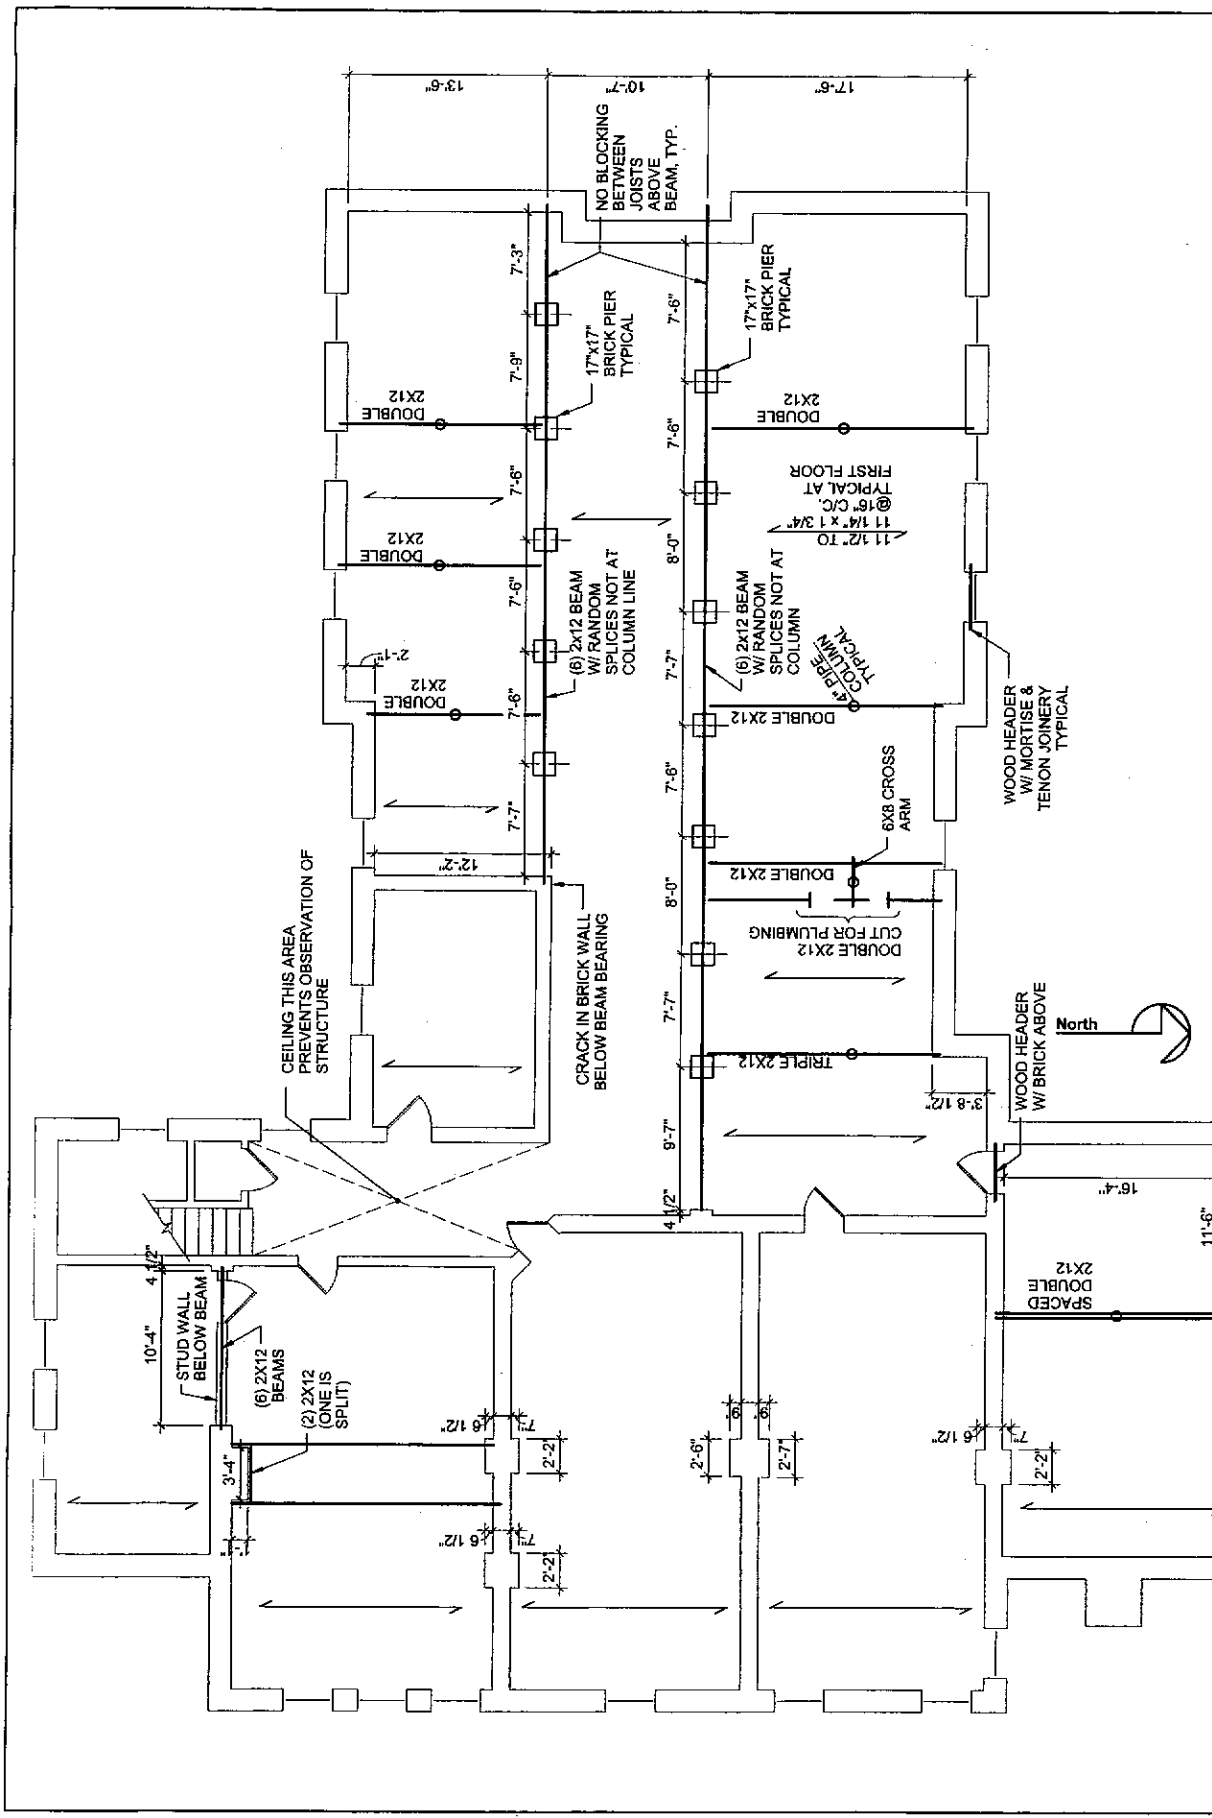
NO BLOCKING BETWEEN JOISTS ABOVE BEAM, TYP.

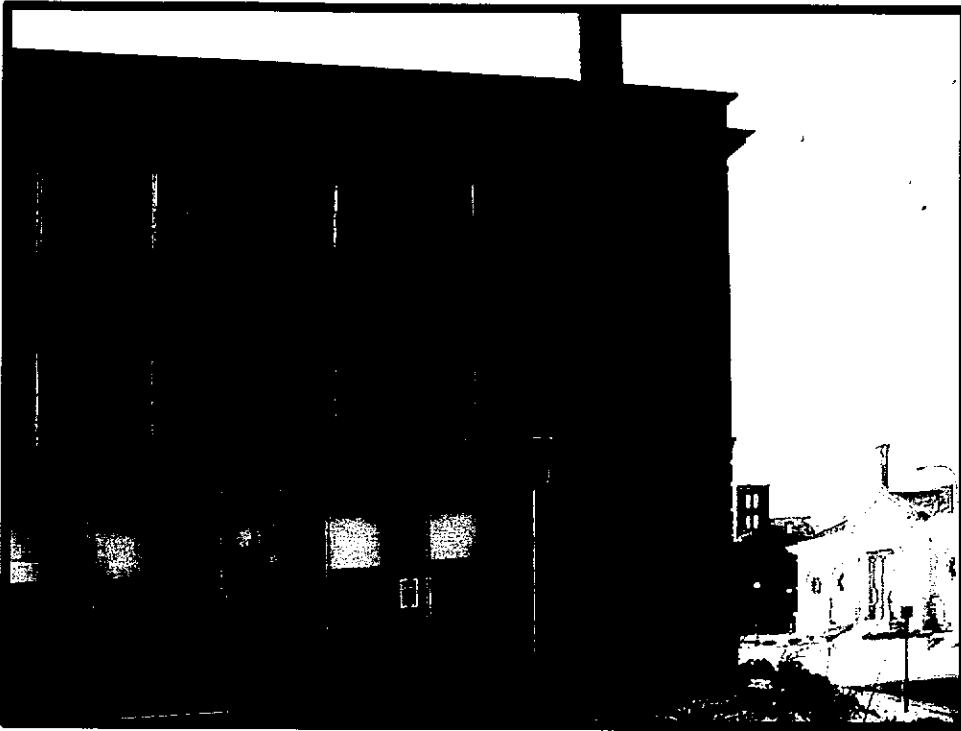
3. EAST SIDE - NOTE: ICICLE'S COMING OUT OF CHIMNEY.

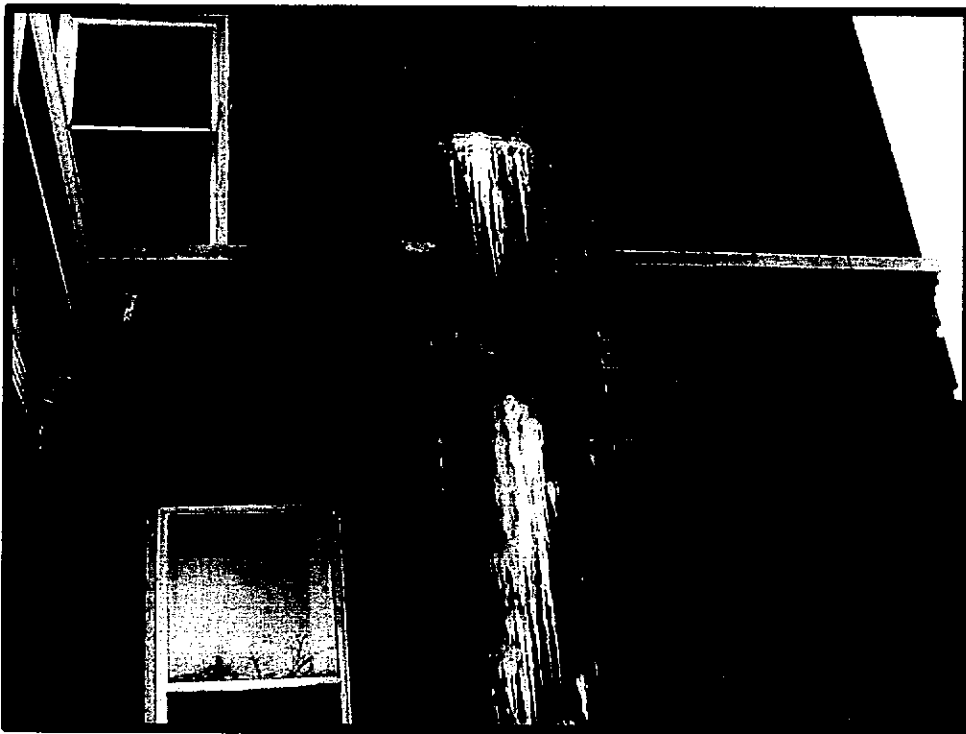
4. CLOSEUP OF ICICLE'S COMING FROM CHIMNEY ON EAST SIDE OF BUILDING.

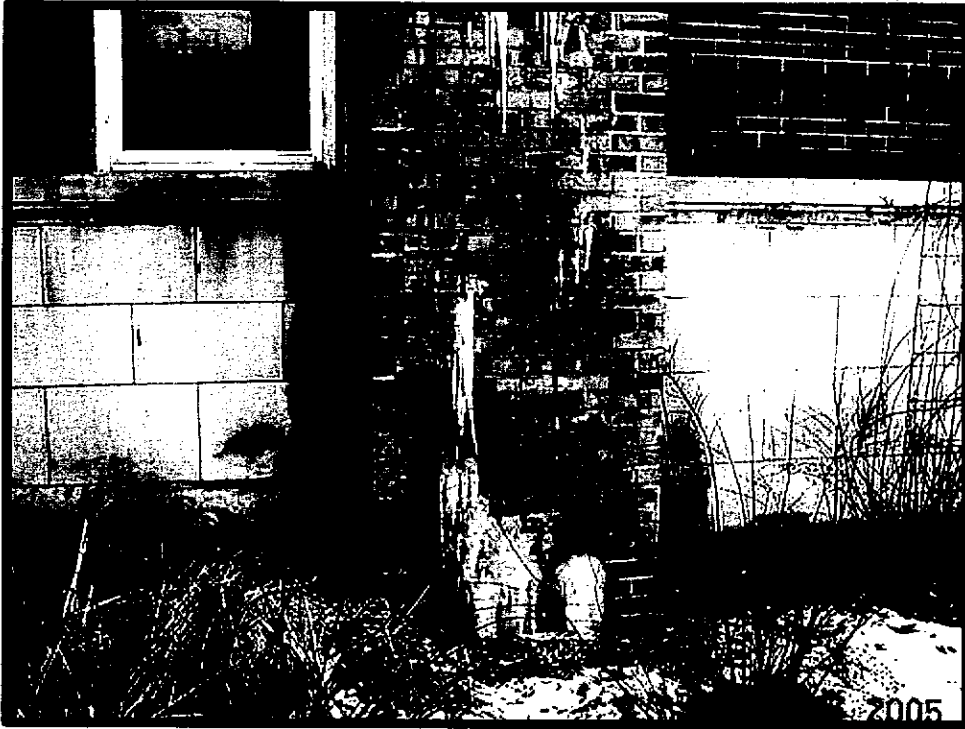
5. CLOSEUP OF ICICLE'S COMING FROM CHIMNEY ON EAST SIDE OF BUILDING.

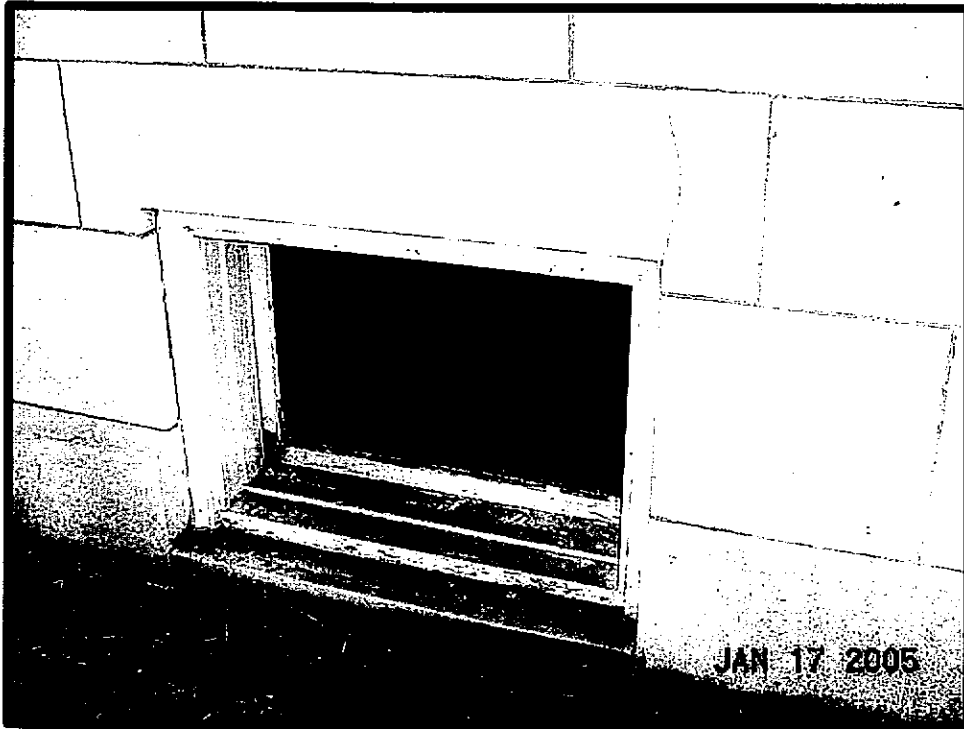
9. CRACKED STONE LINTEL ABOVE BASEMENT WINDOW OPENING.

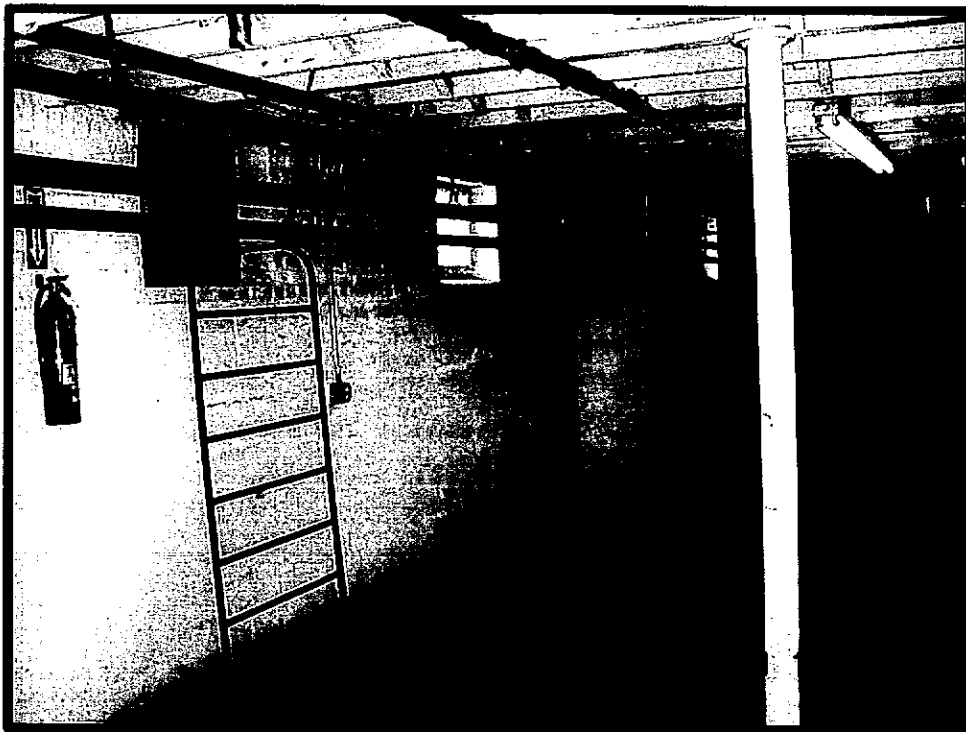
10. BASEMENT LOOKING N. EAST.  
NOTE: COLUMN SUPPORTS DOUBLE JOIST BELOW  
PARTITION LOCATION ABOVE.

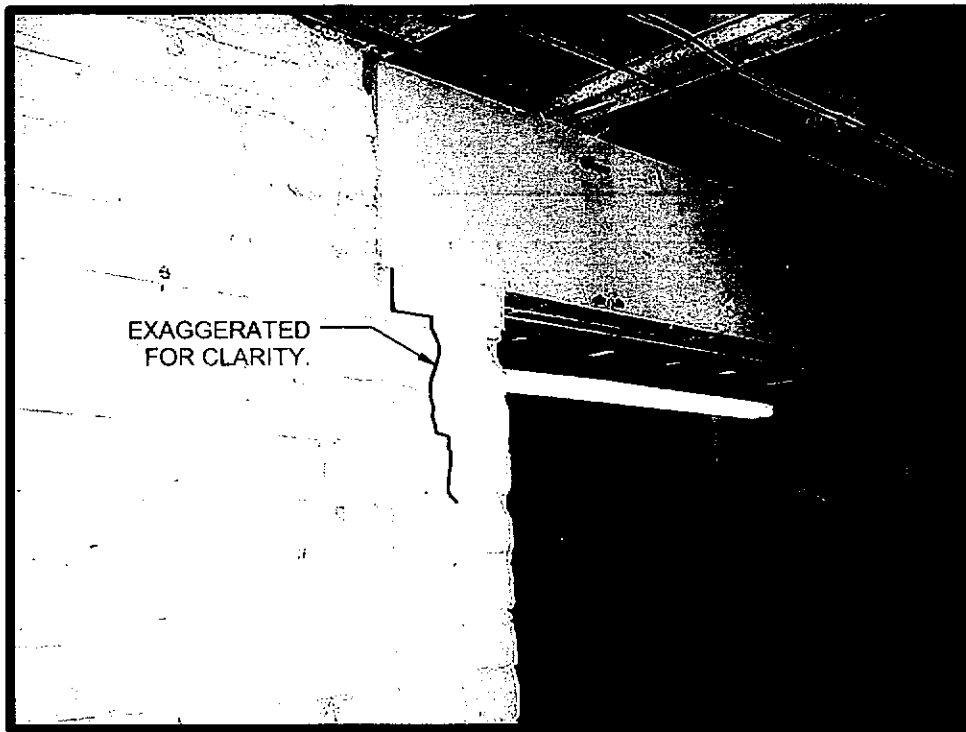
14. CRACKED BRICK AT BEAM BEARING IN BASEMENT.

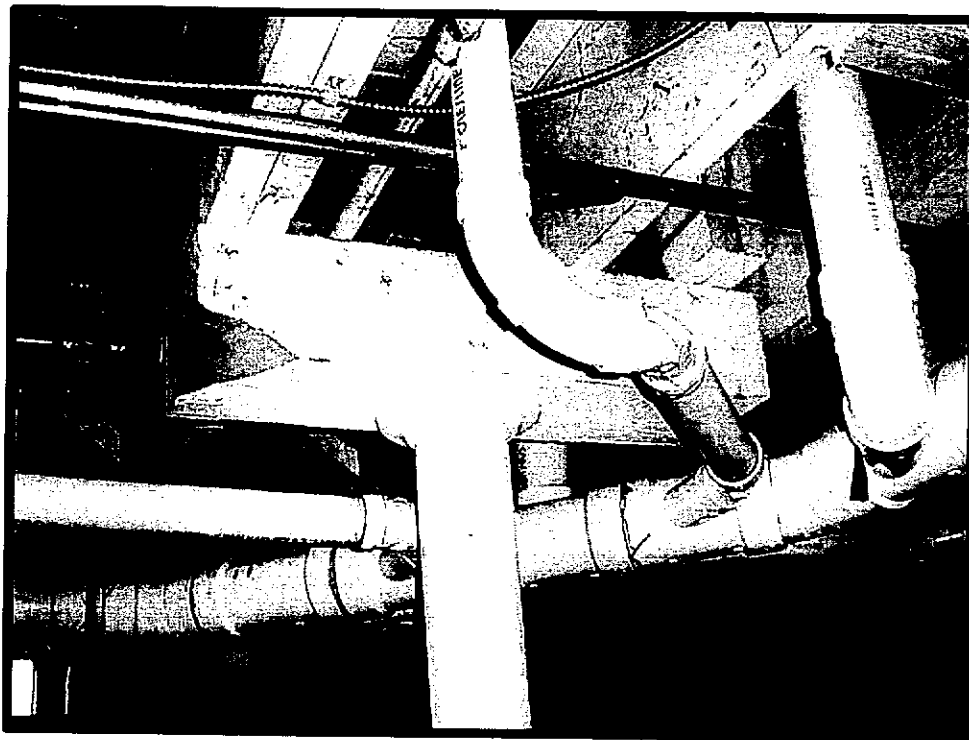
16. SUPPORT COLUMN AND CROSS ARM AT CUT JOISTS BELOW BATHROOM ABOVE. ONE SECTION OF CUT JOIST IS ONLY 14" LONG, BALANCED ON EAST END OF CROSS ARM BEAM.

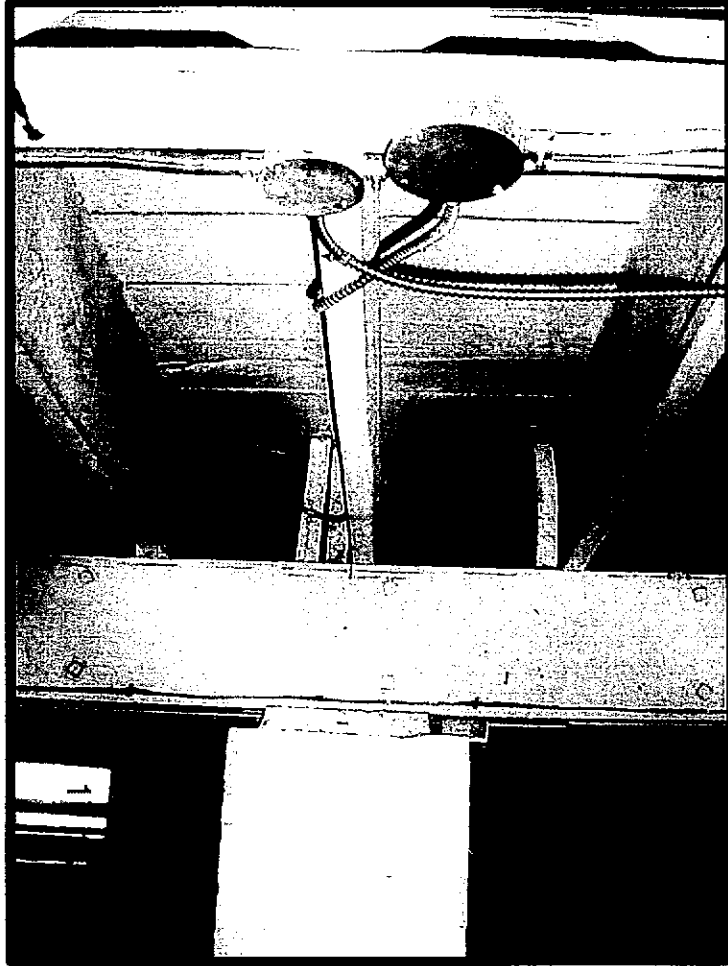
17. TYPICAL BRICK PIER WITH  
(6) 2X12 BEAM  
NOTE: LACK OF BLOCKING  
BETWEEN JOISTS  
ABOVE BEAM.

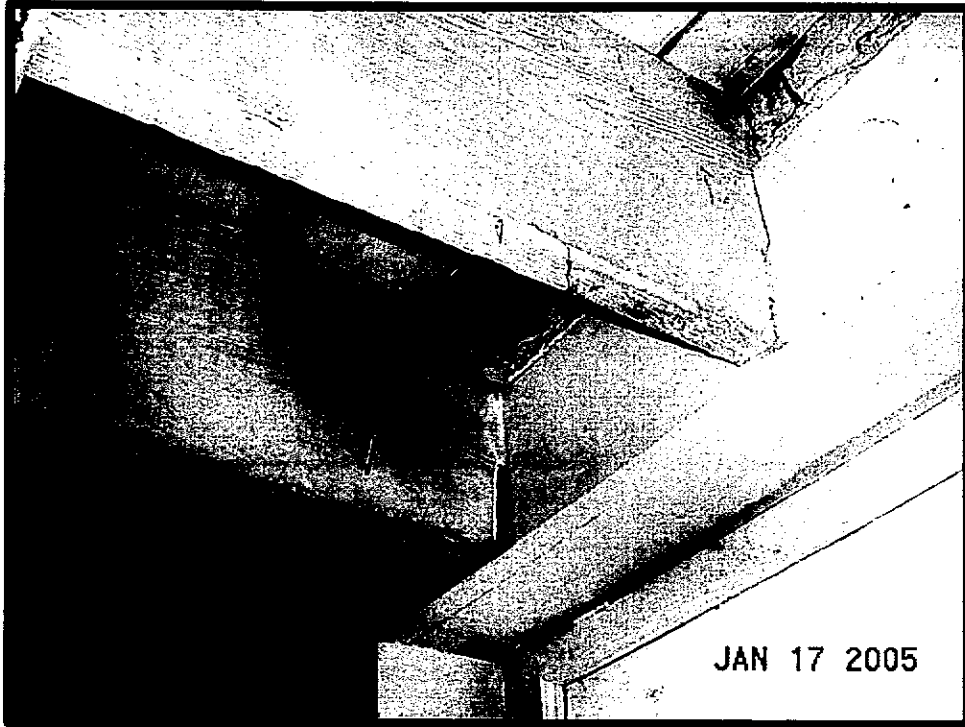
19. JOISTS BEARING INTO WOOD LINTEL AT BASEMENT WINDOW. NO JOIST HANGERS.

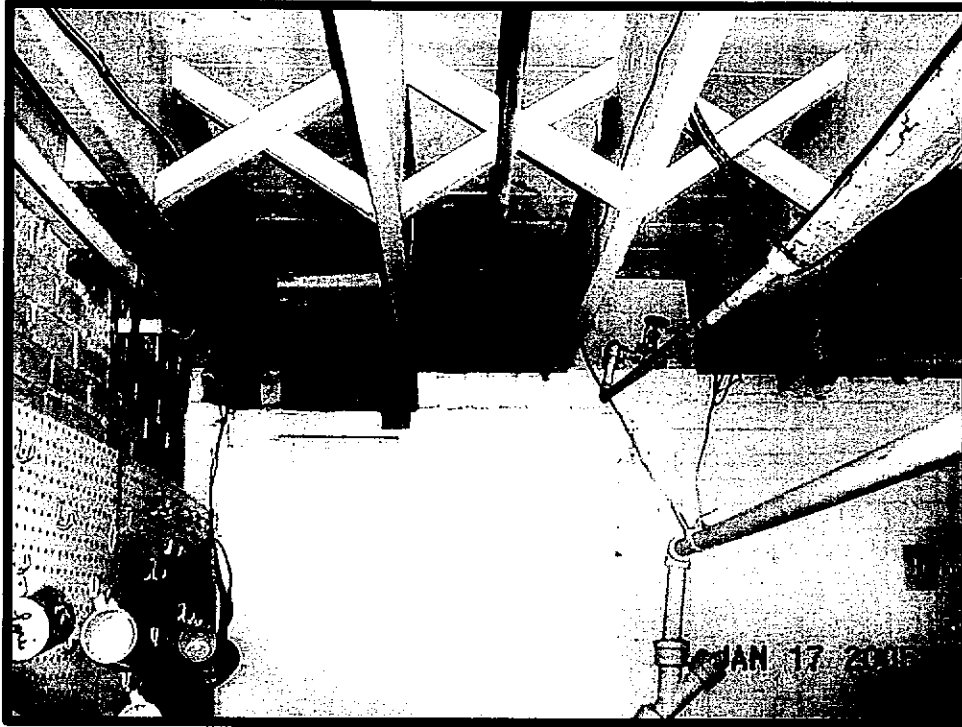
21. EXCESSIVE SIZE OF HOLE CUT IN MASONRY FOR PIPE HAS INTERRUPTED JOIST BEARING.

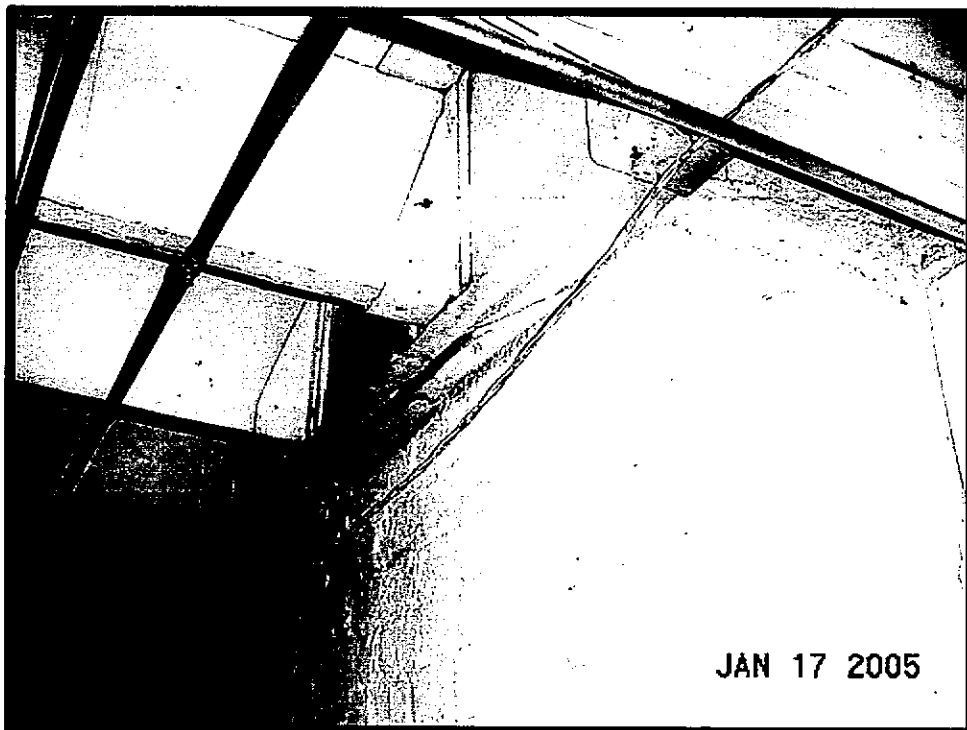
22. SPLIT HEADER AT CHIMNEY IN BASEMENT  
NOTE: JOIST HANGERS.

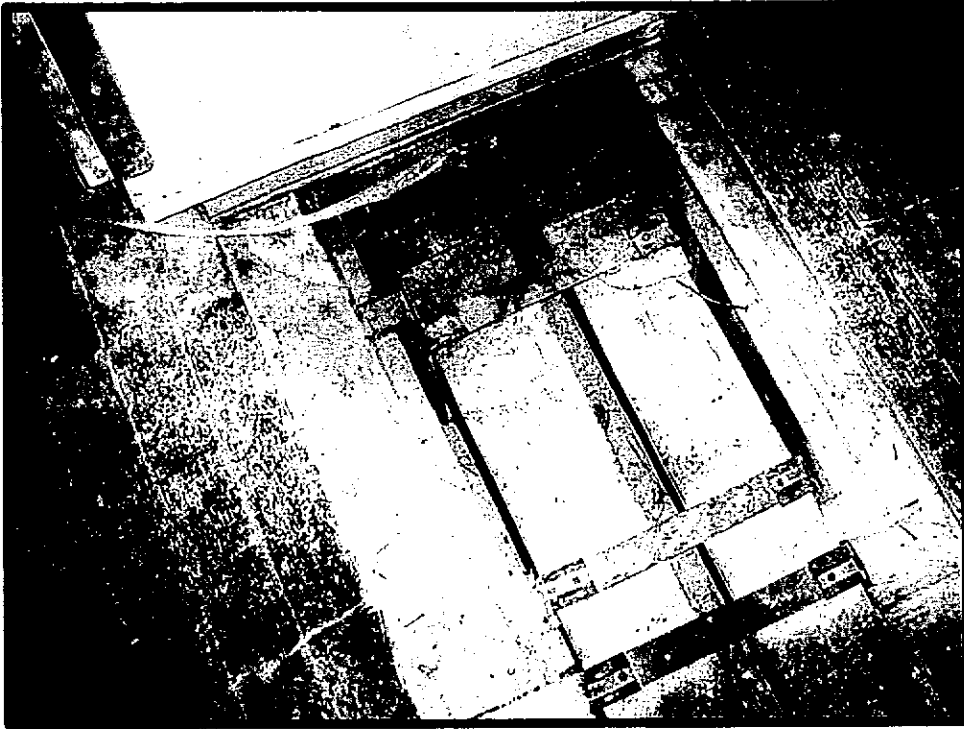
25. TWIN 12"x5 1/4" "I" BEAMS IN FLOOR ABOVE LARGE HALL.  
NOTE: JOIST HANGERS STRAPPED ACROSS TOP OF BEAMS.

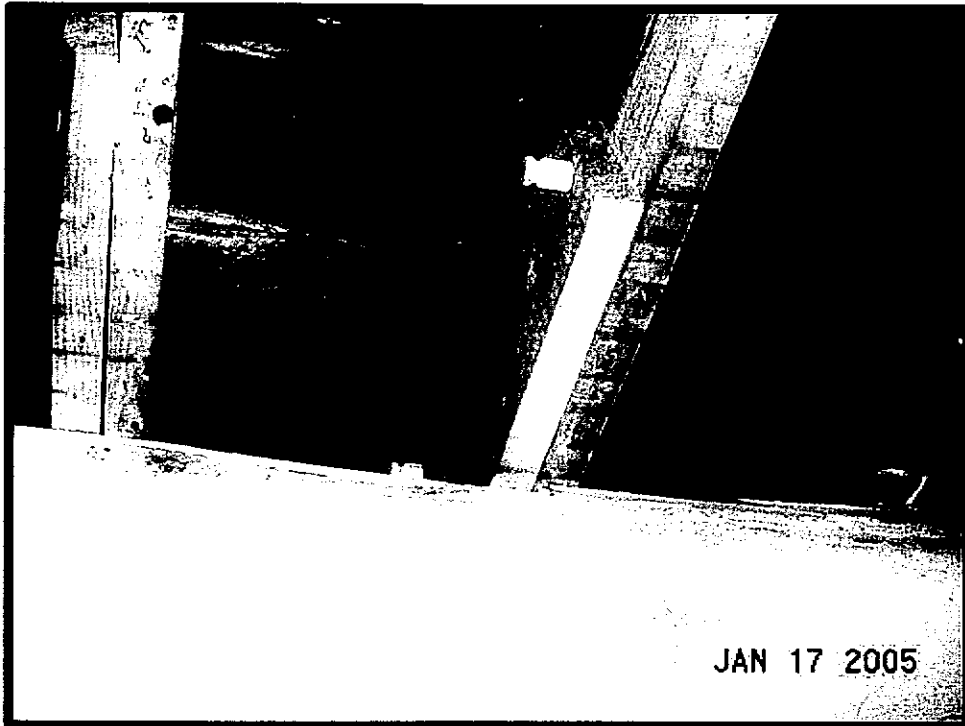
31. KNEE WALL SUPPORTS ROOF RAFTERS WHOLE CEILING JOIST BEAR ON WALL TOP PLATE.

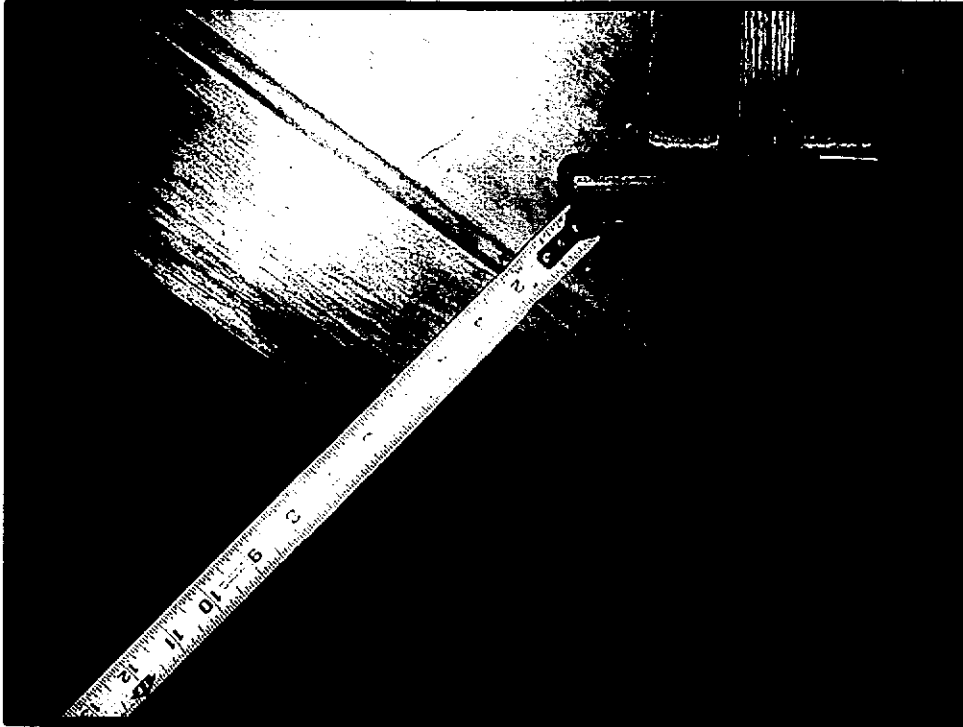
37. STAIR STRINGER LIKELY HAS 5" DEPTH AVAILABLE FOR STRUCTURE BEHIND TRIM AND FINISHES.

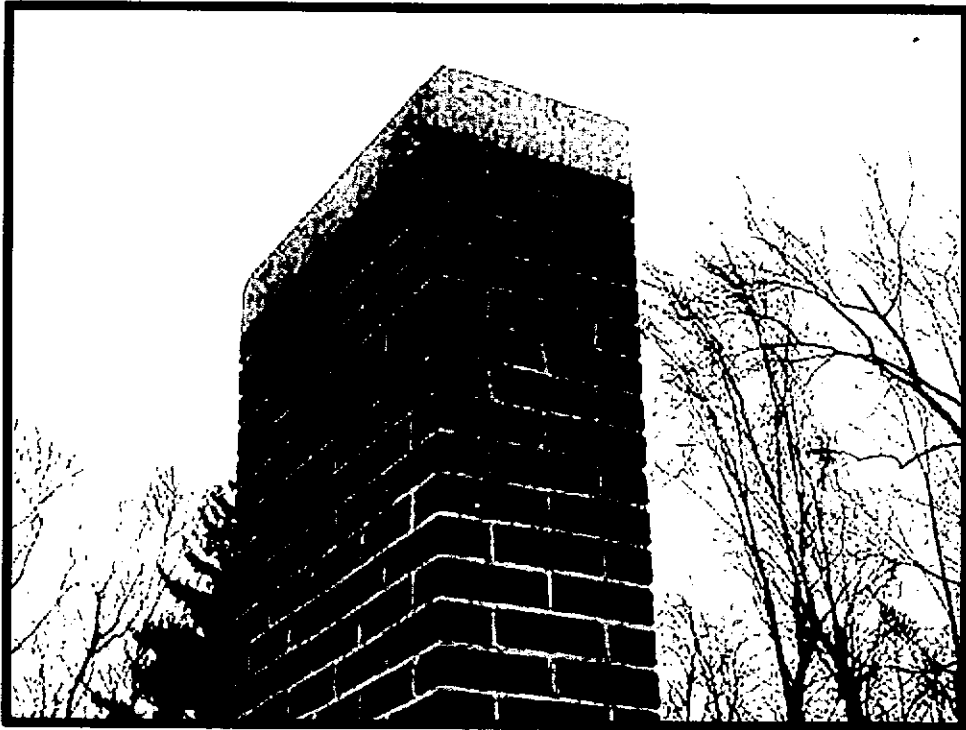
39. CHIMNEY ON ROOF HAS SOME CRACKS IN CAP.

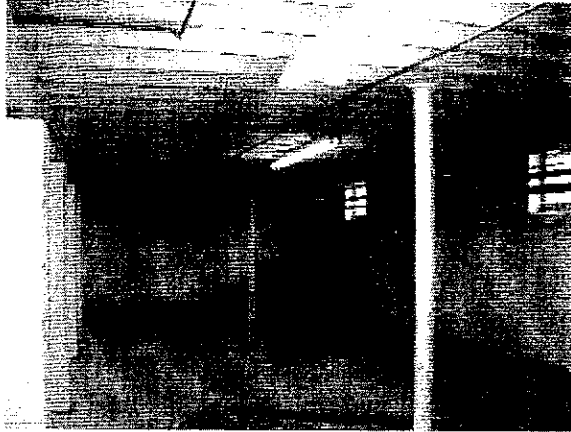
## B. System Piping

Description: The steam piping is original to the building. A visual inspection of the piping system found serious problems. From leaking condensate pipes, deteriorated valves / fittings along with the mixture of schedule 40, copper and galvanized, the piping should be considered to be a total loss and should be replaced. It is not recommended at this time that additional non-destructive testing of the components be completed.

**Short Term:** Demolish piping.

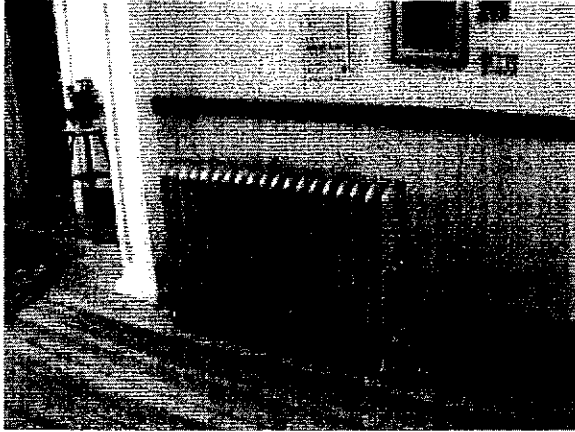
### C. Space Heating

Description: Heating of the space on the first floor is from the original cast iron radiators. The radiators are original to the building. This type of a steam system has few components allowing the system to achieve its long life cycle. Each radiator is equipped with individual shut-off valves, air vents and steam traps. Excessive water hammer in the system was witnessed during the field visit alerting us to the potential of multiple problems within the steam system.
