Long Term Plan for the Rehabilitation of  
the Belrockton Museum and Community Center

**Long-Term Plan for Rehabilitation of the  
Belrockton Museum and Community Center**

Re: Belrockton Existing Conditions and  
Recommendations for Repair

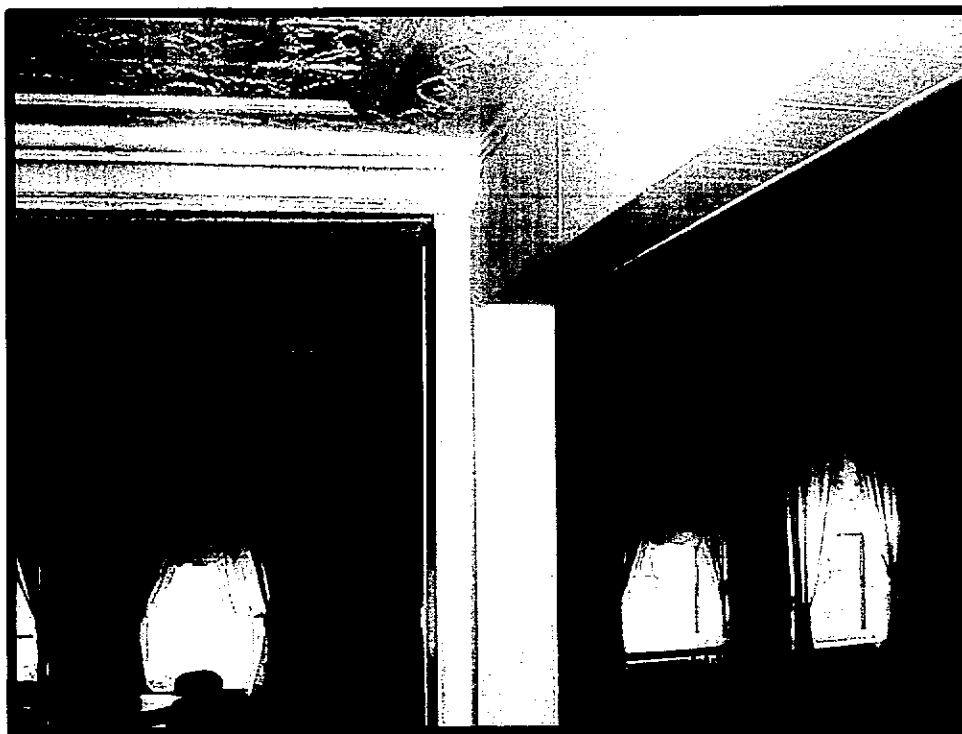
24. "LARGE HALL" LOOKING EAST. NOTE: PRESSED METAL CEILING TO THE LEFT AND POSSIBLE PLASTER OR DRYWALL CEILING TO THE RIGHT.
